Inspection Report

Mine Name: D-tract Asphalt Pit
Operator Name: Wembco

Permit number: S/047/068
Inspection Date: September 2, 2005
Time: 7:45-8:15 AM

S/047/068, D-Tract Asphalt Mine, Wembco

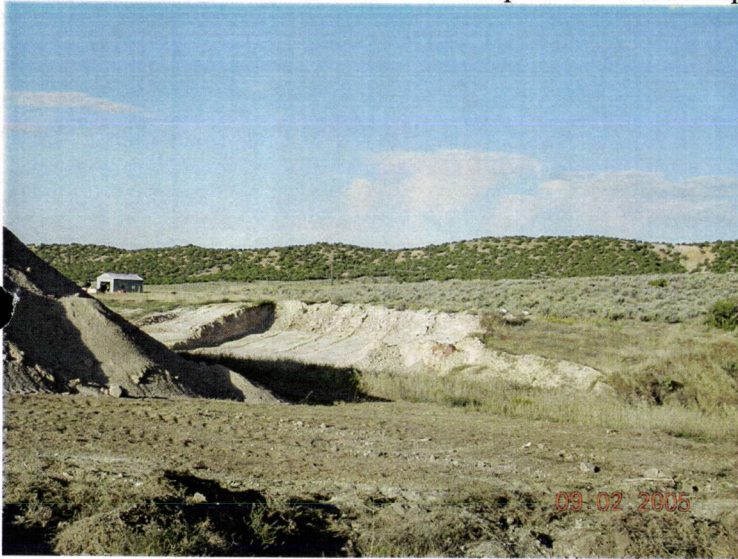
Mr. Allred said the asphalt pit has not been mined this year, a statement verified by the amount of water in the pit. The processing area is being used to process recycled asphalt. Mr. Allred told me he is using some of the overburden from the mine to mix with the asphalt. There are also some other sand and gravel deposits adjacent to the mine the operator has been using (Photo 1).

Photo 1. It appears the operator has been taking some sand and gravel from a deposit adjacent to the mine.

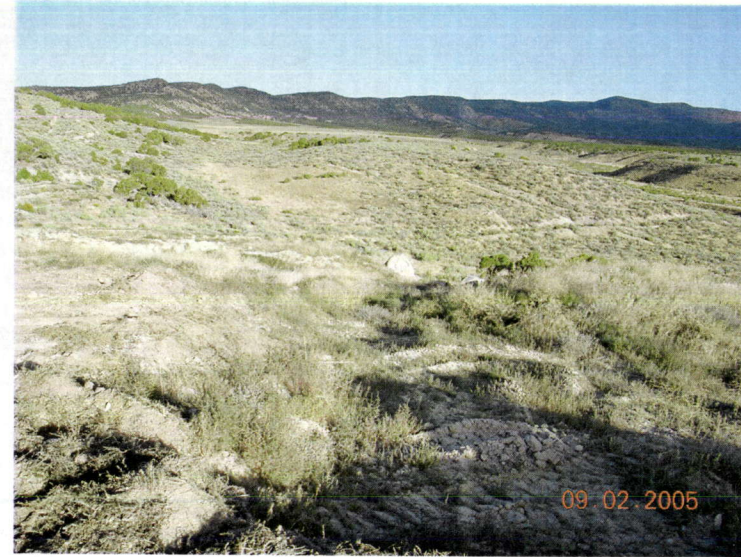
Photo 3.

There is an area of 0.76 acres on the west side of the mine that needs to be reclaimed (Photos 2 and 3). The condition of this area has not changed since I last visited the site.

Photo 2. This and Photo 3 are views of the area that needs to be reclaimed.

Previously, the operator was reluctant to reclaim the area west of the mine because it overlies some asphalt and because there was a prospective buyer for the property that might want to mine this area. There have also been some delays due to weather. Whether or not there is a potential for mining this area, this site is permitted as a small mine, and the disturbed area needs to be five acres or less. This

reclamation must be done this fall or further enforcement action will be taken. (This area was the subject of a Division Directive before the Division's current enforcement rules went into effect.)
